# Green Infrastructure Rapid Assessment Plan: Thomas Creek Watershed

Stormwater Coalition of Monroe County

Monroe County Department of Environmental Services

**December 2013**

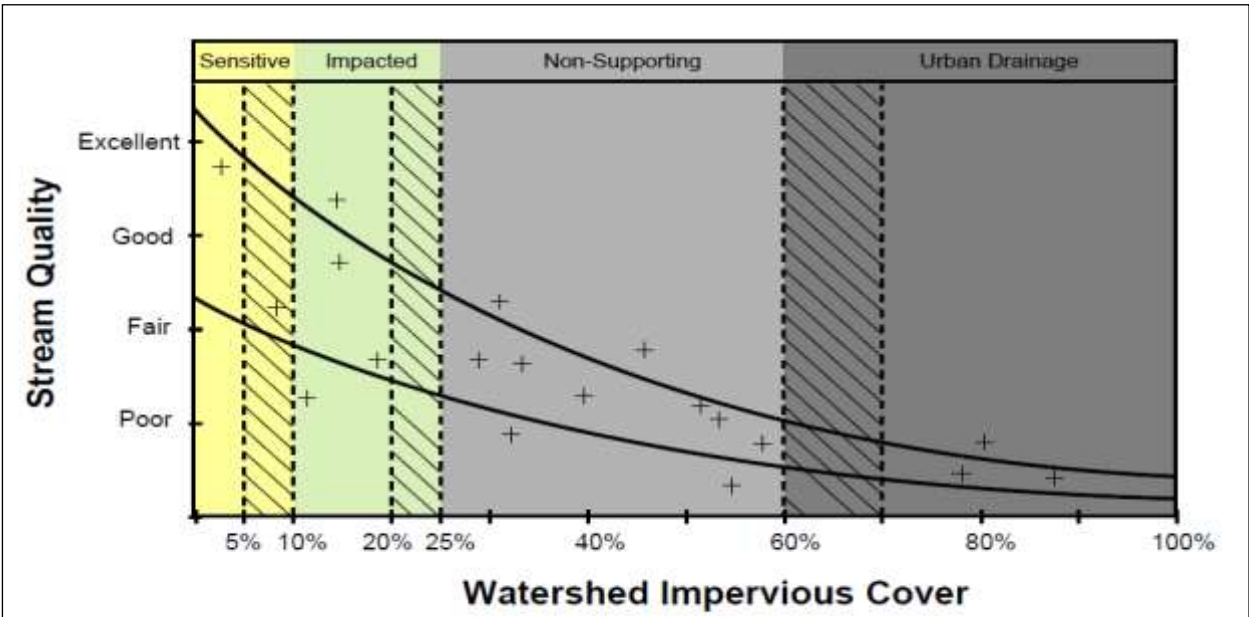
Figure 3: Impervious Cover Model

**1.4.2 Impervious Cover Analysis** The Center for Watershed Protection created the “Impervious Cover Model” (ICM) to predict a typical stream’s health using the relationship between subwatershed impervious cover and stream quality indicators. The models accuracy has have been confirmed by nearly 60 peer-reviewed stream research studies (Figure 3) . The ICM shows stream quality decline becomes evident when the watershed impervious cover exceeds ten percent. Thomas Creek has an average of 19.5% impervious cover, placing stream quality somewhere between poor/fair and good, indicating that the stream is impacted.
